Test Report

**LG Electronics, Inc.
LG Q60, LG K12 Prime, LG X6 2019, LG K50, LG K12 Max**

MIL-STD-810G

MET Report: ESL102896-MIL REV 1

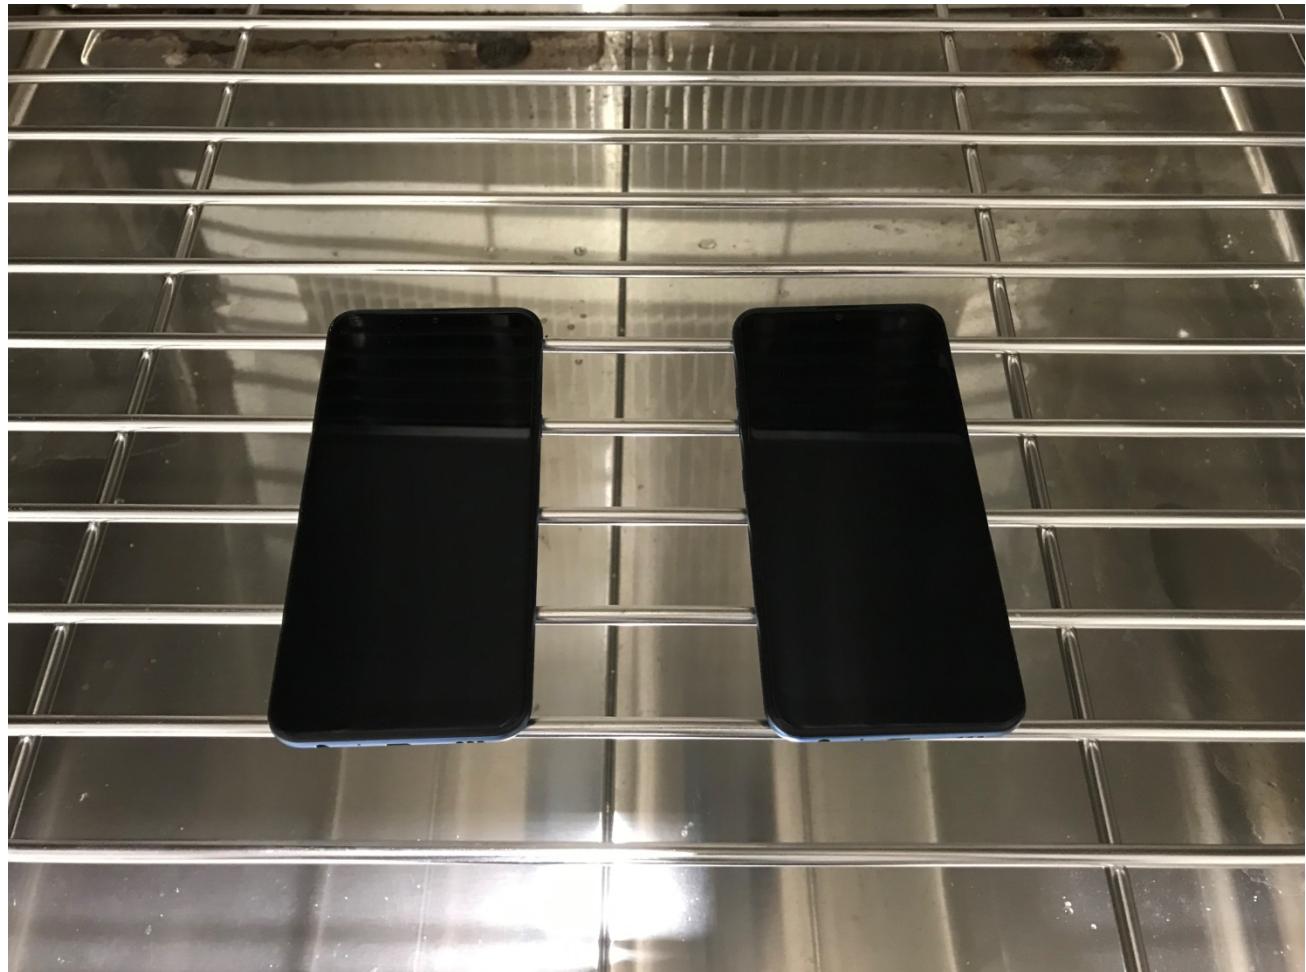
Figure 2: High Temperature, Procedure I – Storage, Setup
